OPERATION PLUMBBOB

Project 30.6

TEST OF FRENCH UNDERGROUND
PERSONNEL SHELTERS

TEST OF FRENCH UNDERGROUND PERSONNEL SHELTERS

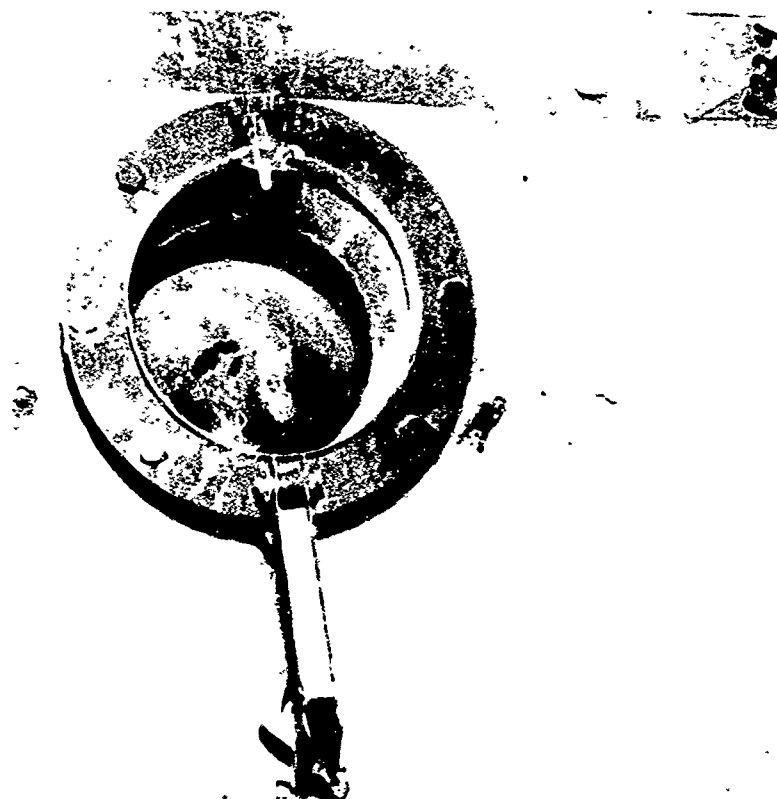
Fig. 3.11—Internal blast results of interior end of exhaust pipe.
